**Mattson  
Macdonald  
Young**  
structural  
engineers

24 November 2015

Project No.: 15689.00  
Re: Structural Condition Review of the building at 216-218 Bates Ave.

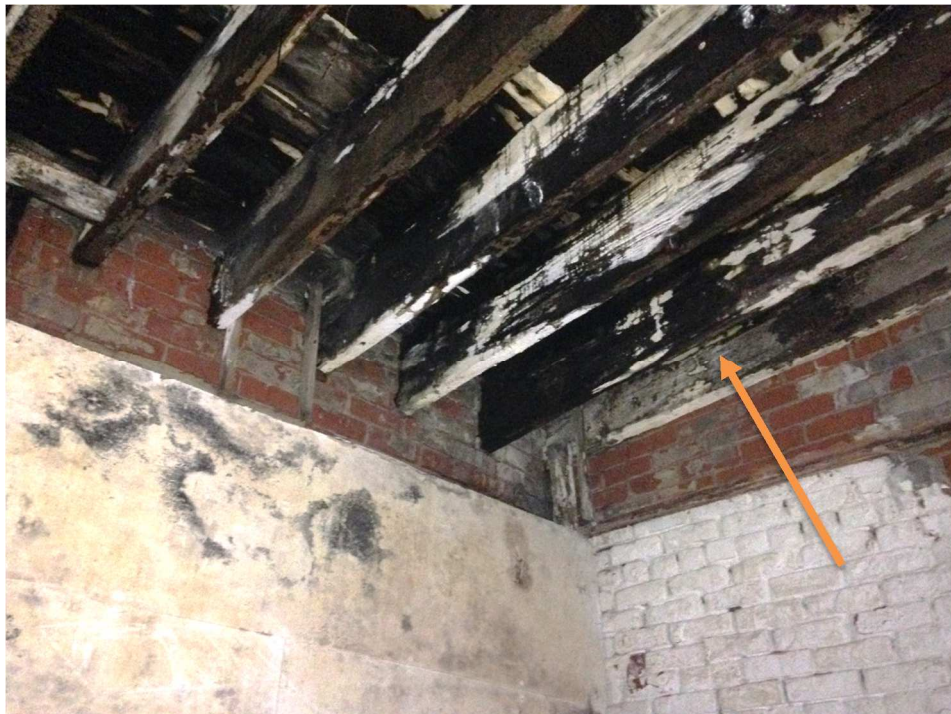
Water damage is found throughout the building. Mold is on almost all of the walls and roof joists that we observed and most of the rugs that we found on the ground were very wet. Picture 1 shows a few of the joists that have been damaged. Picture 2 shows walls and other various items that are damp and damaged due to water infiltration. The roof joists rest on a steel beam that runs through the center of the building. The steel beam is rusting, as shown by Picture 3. The steel beam has an estimated section loss of 5%. As the beam continues to rust there will be more of its section lost. A large hole was found in the roof which can be seen in Picture 4. It is likely that there is extensive damage, other than the pictured hole, throughout the roof that is causing the water to infiltrate the building.

**Picture 1 – Water Damage to Roof Joists**

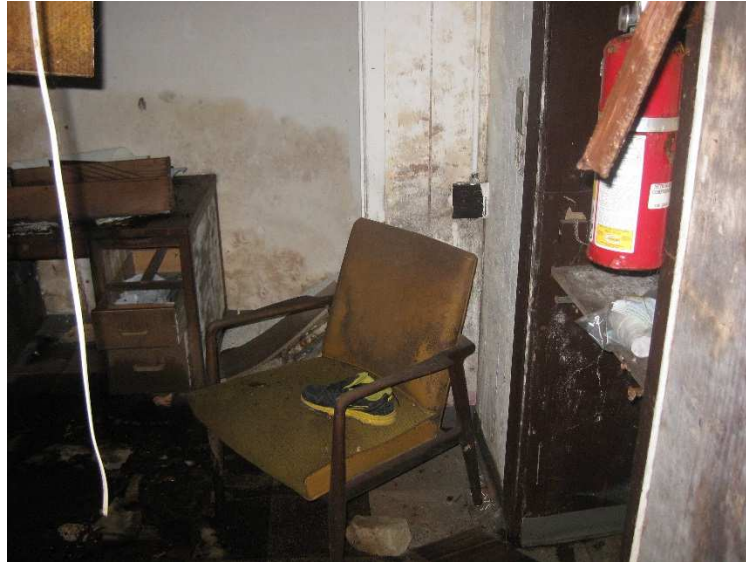
**Picture 2 – Water Damage to Walls**

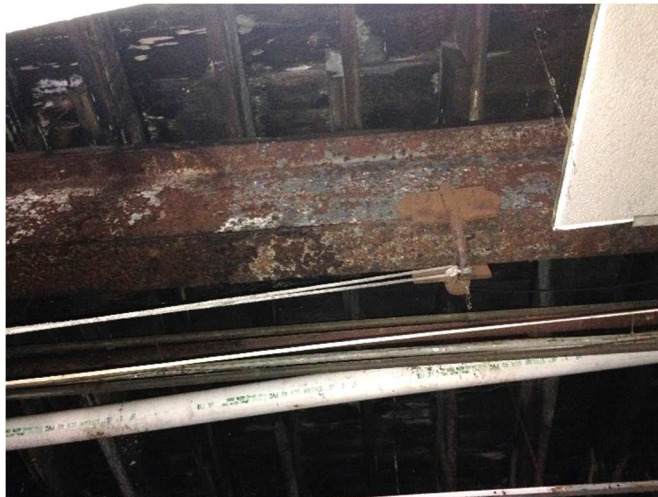
**Picture 3 – Rusting Steel Beam**

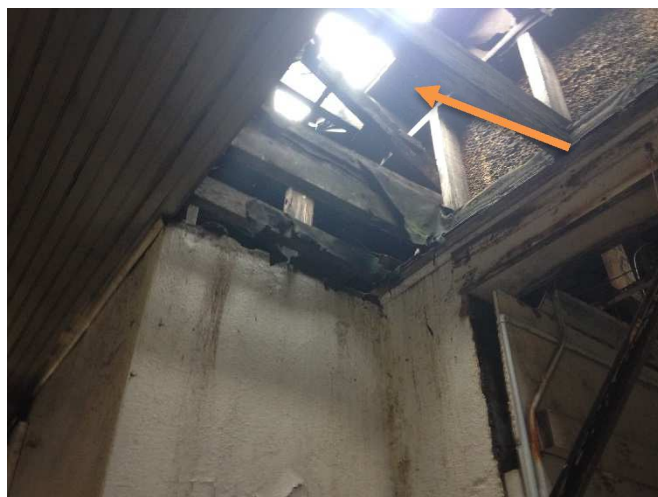
**Picture 4 – Hole in Roof**

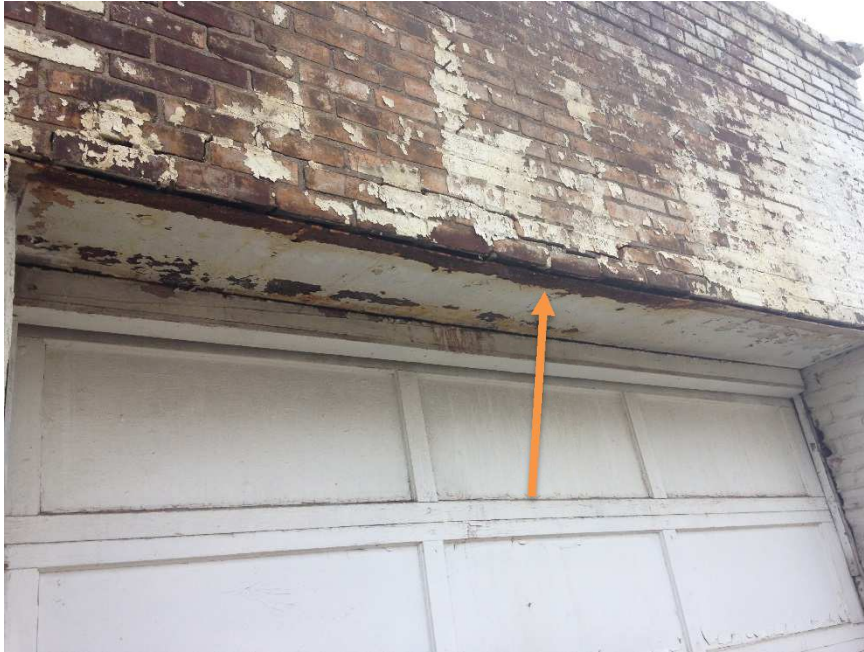
The lintel above the garage door at the northwest wall of the building is rusted and deflecting. The steel lintel has an estimated section loss of 5% due to rust. As the lintel continues to rust there will be more of its section lost. The deflection is causing some of the clay masonry bricks above it to crack. Picture 5 shows the lintel. The parapet above the garage is tipped outward at the top. The parapet damage is likely due to water infiltration and freeze thaw and/or inadequate tie to the building. Picture 6 shows the underside of the parapet. With the exception of the leaning parapet, the exterior walls appeared to be plumb. Picture 7 shows the profile of the northeast wall.

**Picture 5 – Deflecting Lintel at Northwest Wall**

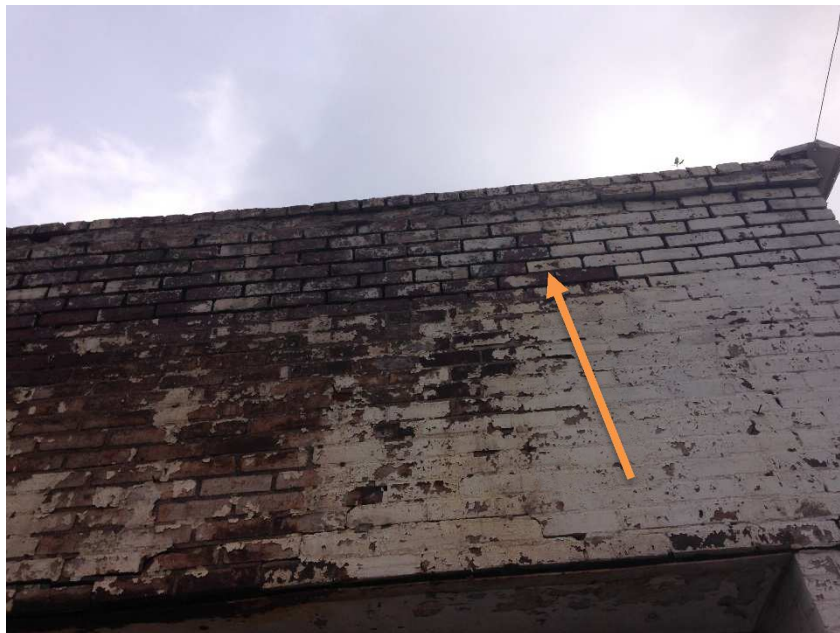
**Picture 6 – Leaning Parapet at Northwest Wall**

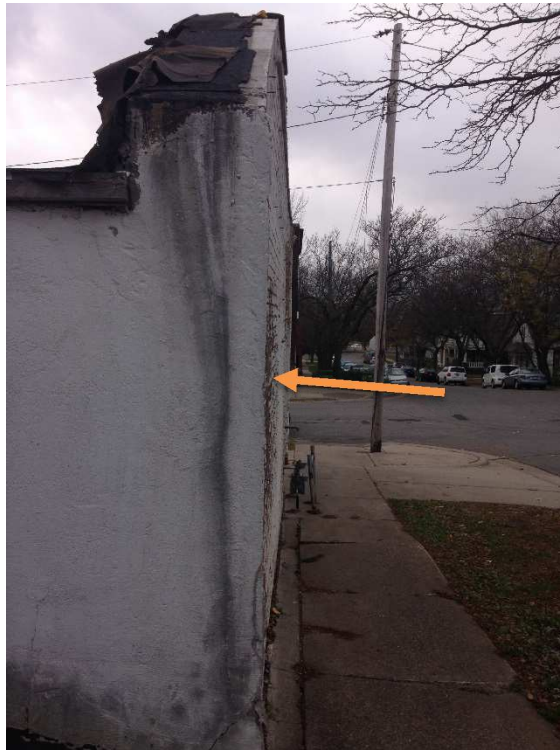
**Picture 7 – Northeast Wall**
